# orbit

Volume 30 | Number 1 | 2010

A Technical Publication for  
Advancing the Practice of  
Operating Asset Condition  
Monitoring, Diagnostics, and  
Performance Optimization

Are XY Radial Proximity  
Probes Really Necessary?  
Page 4

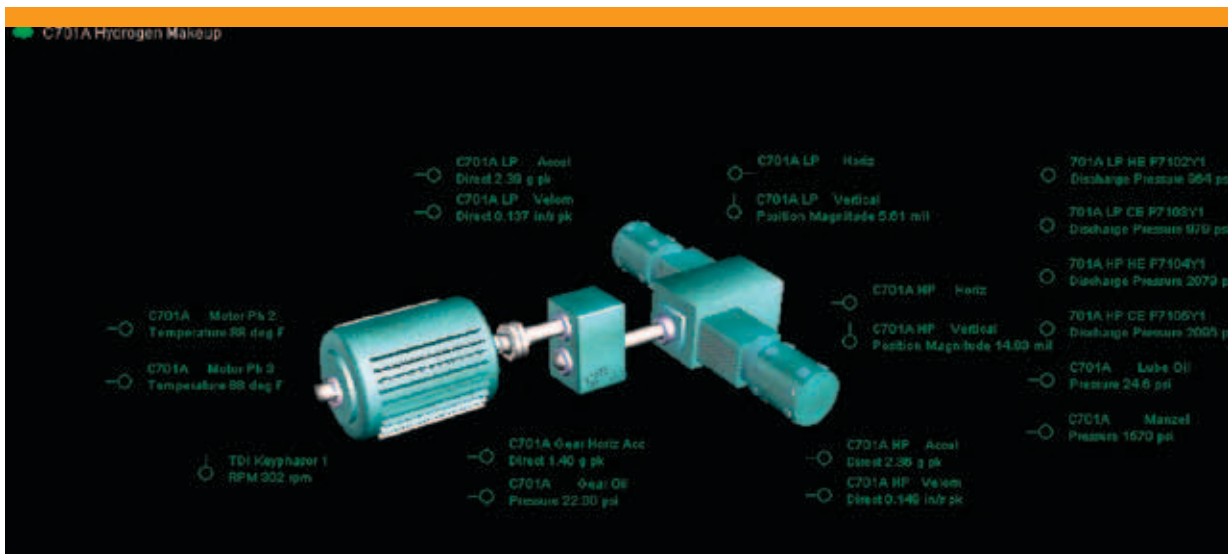
Figure 1: System 1\* View of the machine train: motor, gearbox, reciprocating compressor, and parameters.

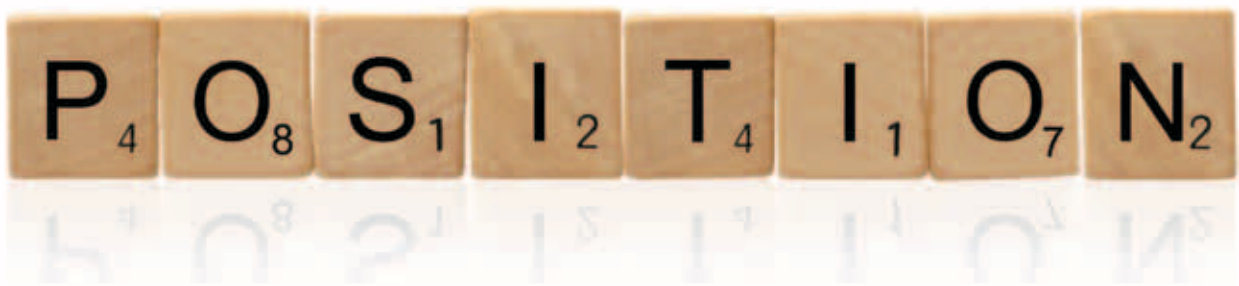
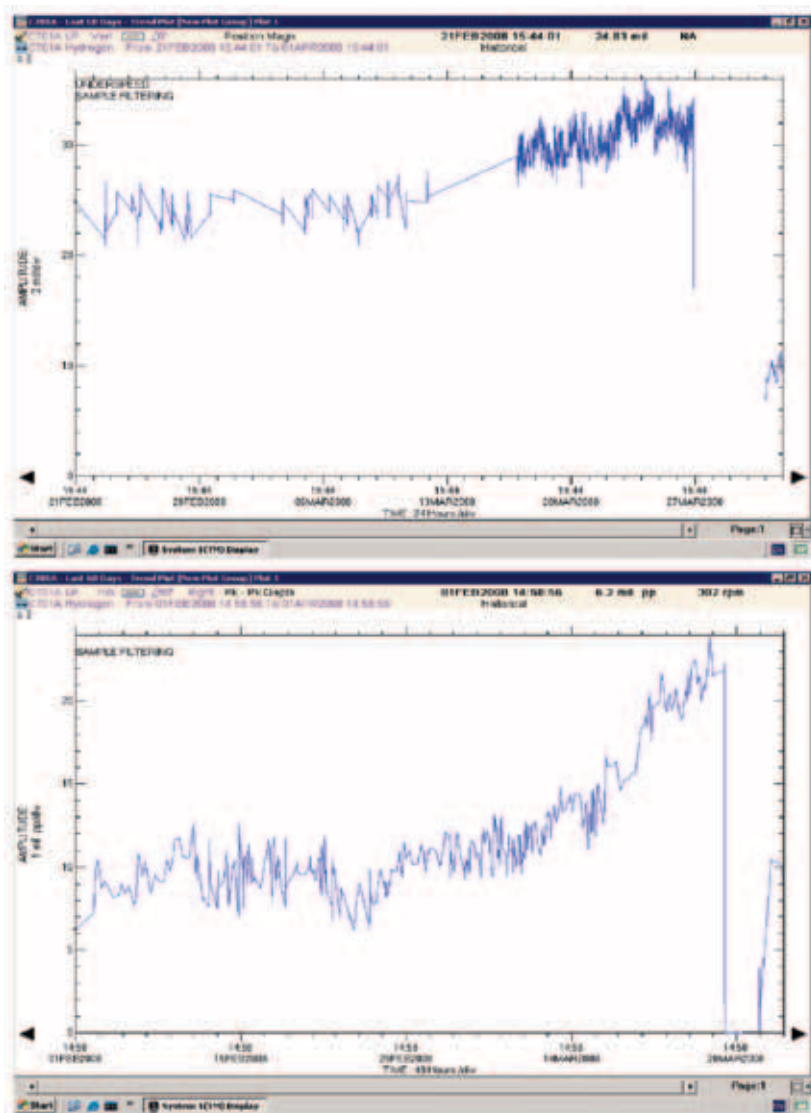
Figure 2: System 1 Trend plot for Rod Position magnitude (top) and horizontal peak-peak displacement (bottom)

Shortly after the overhaul in June 2007, an unusual rod position pattern was observed. The center of the rod position deviated from its normal position and the piston rod position moved with patterns that did not repeat. Eventually the rod position magnitude alarm came in and our Machinery Diagnostics Services (MDS) team was called to review data. Toward the end of February 2008 operations reported hearing a slight knock on the first stage. The plant engineers reviewed all the data and the rod position probe mounting, and concluded that the rod movement was real. Since the amplitude change occurred in both horizontal and vertical directions and the probe mounting was not impaired visibly, the malfunction of the probes themselves was ruled out as the cause for the rod position movement pattern change (Figure 2).

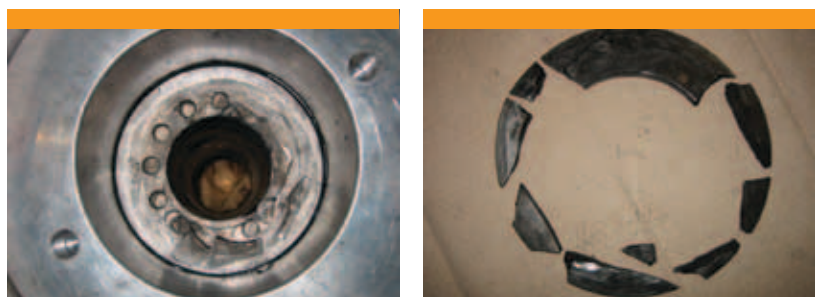
**Figure 4:** Minovar Piston Collar Damage

First, the crosshead Superbolt® was inspected and was found to be in good condition. All crosshead and crosshead pin clearances were found to be within specification. Next, the cylinder head was removed, revealing the piston nut damage. The minovar collar was found to be severely deformed and the piston rod had suffered thread damage. The collar and piston assembly were replaced, and the compressor returned to service without production loss.

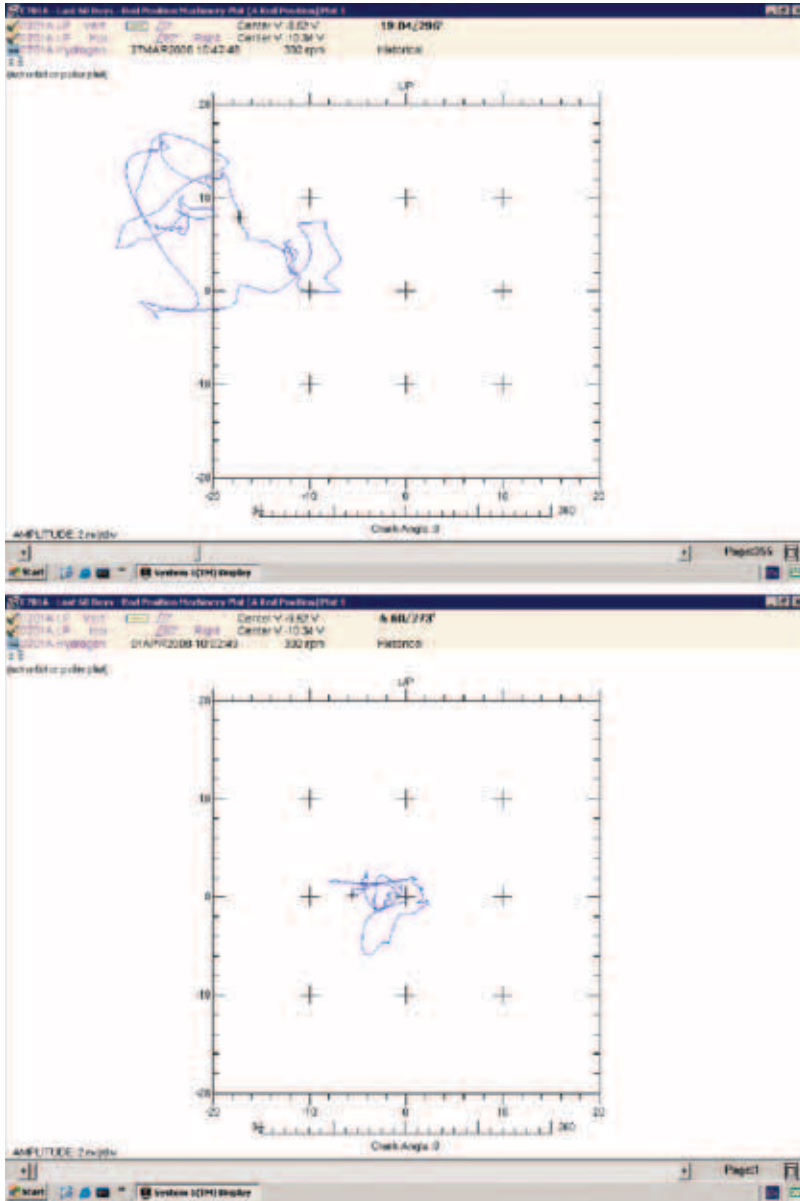
Figure 5: System 1 Rod Position plots before (top) and after (bottom) repair.

After repair, the rod position plot showed rod displacement reduced and rod position moved to the center (Figure 5).

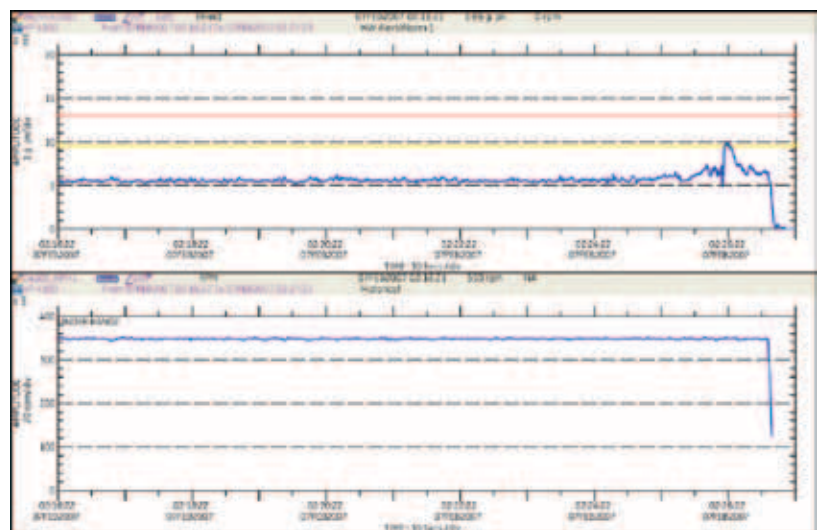
Figure 2: 5th Stage Unfiltered Crosshead Accelerometer Vibration Trend (upper plot) Machine rpm (lower plot)

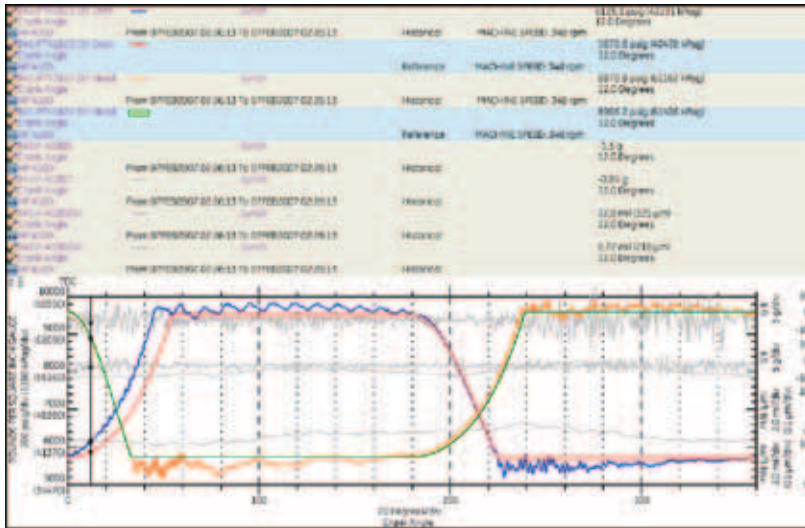
**Figure 5:** 5th Stage Cylinder Pressure, Cylinder Acceleration, Crosshead Acceleration and Rod Position Versus Crank Angle. 07 Feb 2007 02:26:13.

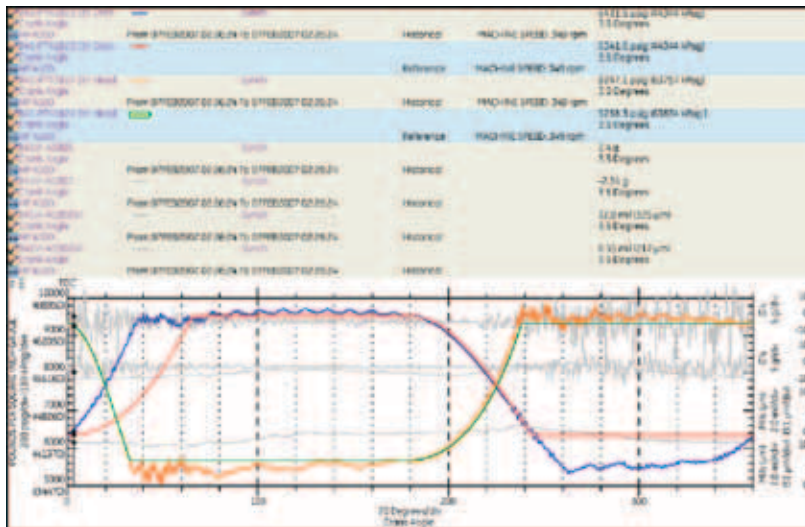
**Figure 6:** 5th Stage Cylinder Pressure, Cylinder Acceleration, Crosshead Acceleration and Rod Position Versus Crank Angle. 07 Feb 2007 02:26:13.

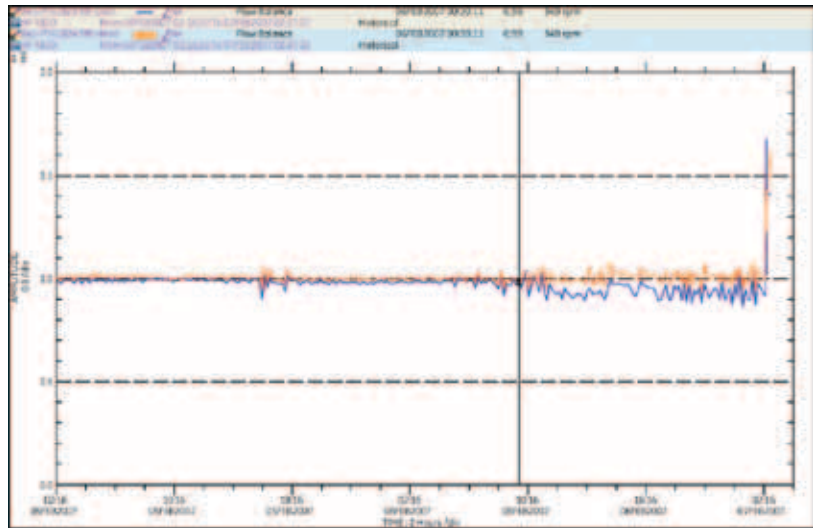
Figure 7: 5th Stage Flow Balance Trend.

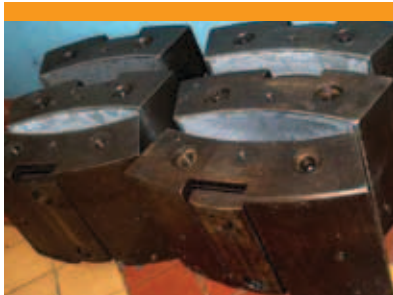
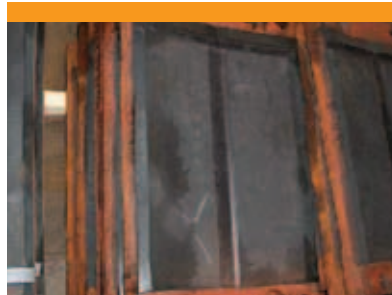
**Figure 1:** Examples of metallic (up) and rubber (down) segments of various guide bearings.

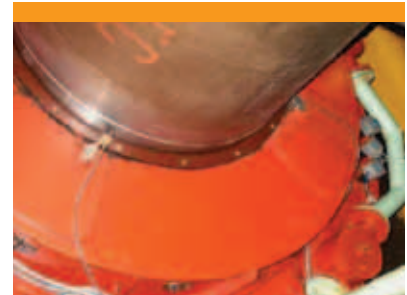
**Figure 2:** An example of XY transducer configuration where probes are connected to guide bearing cover.

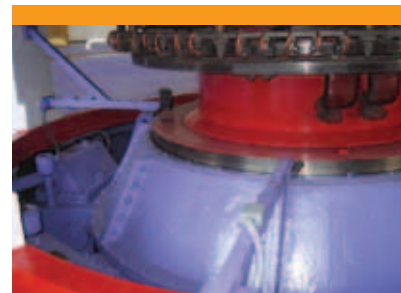
**Figure 3:** Examples of XY transducer fixings allowing measurements of rotor absolute vibrations:

a) Two rigid bars holding non-contact transducers are connected to a static structure

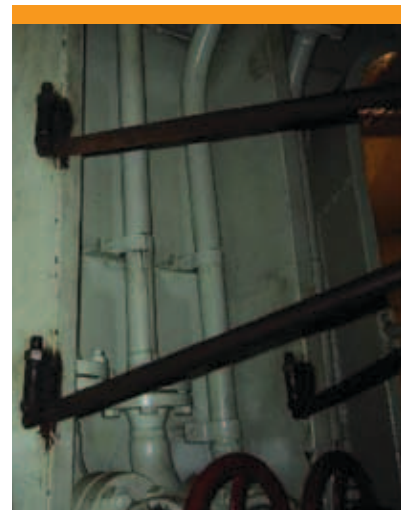
b) An example of transducer holder inside of a hydro-generator chamber: holder fixing to the chamber wall (top), and holder head – allowing non-contact transducer connection (bottom).

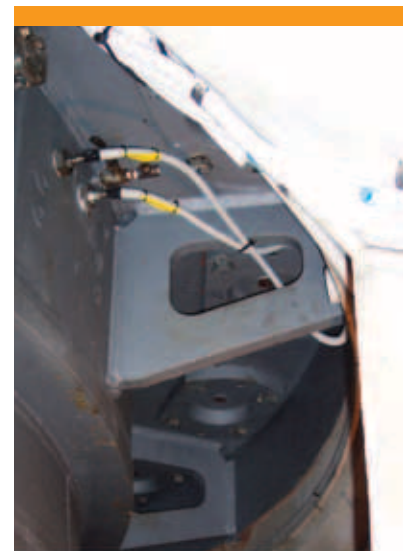
**Figure 5:** An example of redundant XY transducer observing shaft in the closed space (only one of XY transducer and its redundancy is visible at the photo)

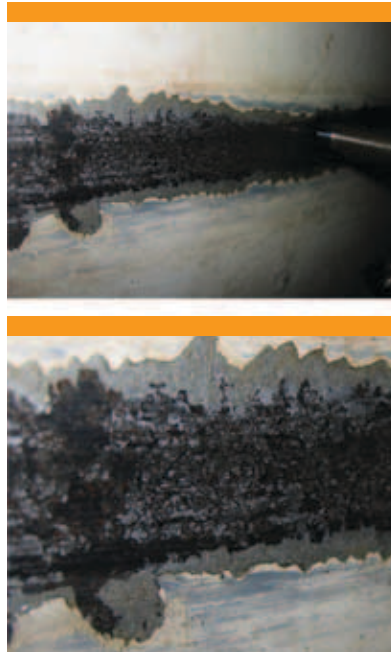
**Figure 6:** An example of eddy current transducer operating with a 250MW hydro-generator shaft in area close to the guide turbine bearing (upper) and closer view of the shaft surface (lower).

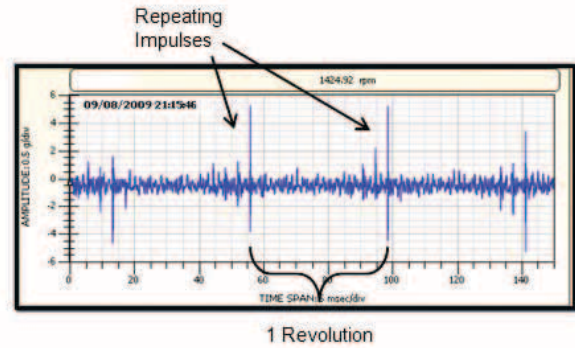
**Figure 2:** High-speed acceleration waveform from ADAPT.wind software showing periodic impulse patterns. The patterns repeat once every revolution.

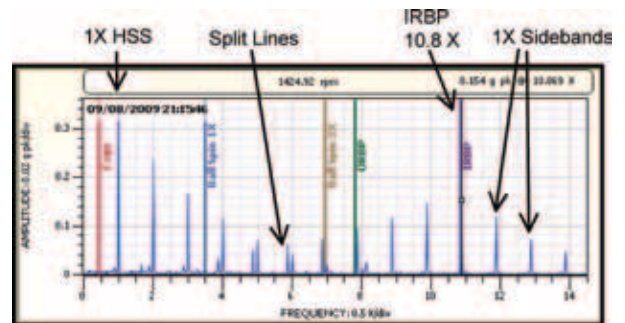
**Figure 4:** Acceleration envelope spectrum of waveform in Figure 2 (September 2009). The key bearing fault frequency lines are overlaid on the plot. The IRPB fault line is a perfect fit to the data. The split lines show that the two harmonic series are separated. Data processed in ADAPT.wind software.

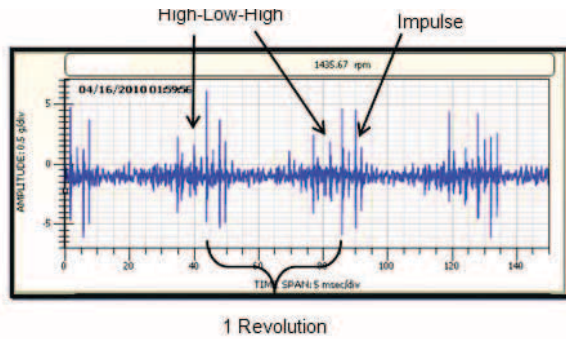
Figure 5: Data from the same bearing as Figure 2, but several months later. The vibration signature has become more complex.

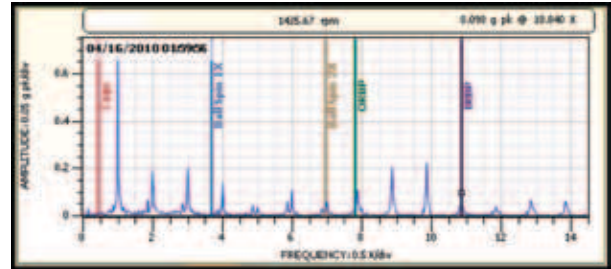
Figure 6: Data from April 2010. Compare to Figure 4. The amplitude of the IRBP line is lower, while the 1X line amplitude is higher.

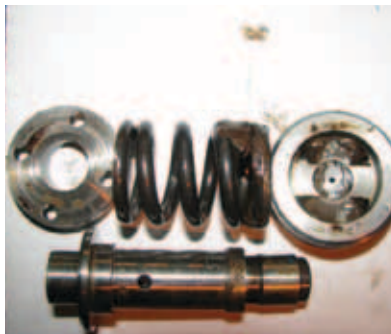
Sludge in trip bolt mechanism.

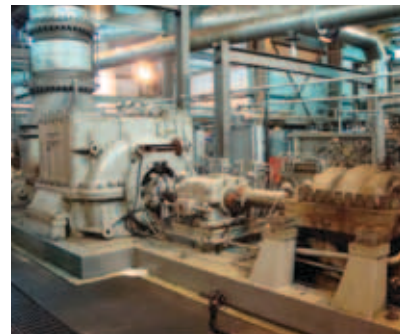
Process air compressor, compressor train.

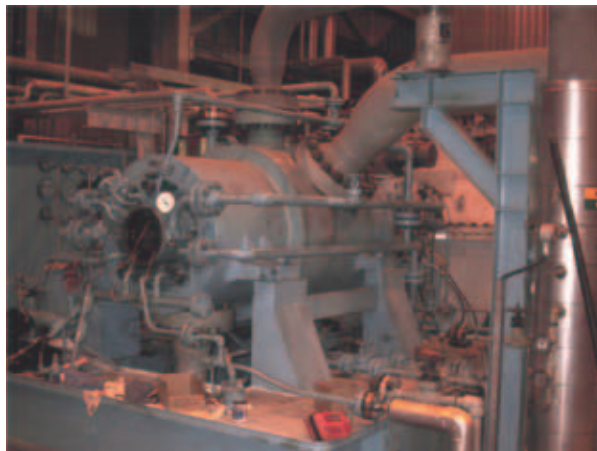
Synthesis Gas Compressor, High Pressure Case.
